# ENERGY PIPELINE

# EXPOSURE TO LIGHTNING STRIKES AT INJECTION WELL FACILITIES

BY GARY BEERS • FOR ENERGY PIPELINE

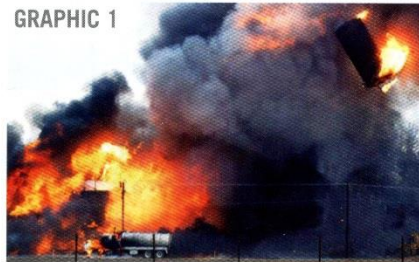
GRAPHIC 1

In April 2015, a commercial, produced-water, injection well facility adjacent to the Greeley-Weld County Airport was struck by lightning. It exploded and continued to burn for several hours (Graphic 1, Source: Greeley Tribune). Several days later, 18 miles southeast of the Denver International Airport, a smaller IJ well facility operated by an oil company was struck by lightning and a fire resulted. This northeast region of Colorado experienced an abnormal number of severe thunder and lightning storms during April but why did these water-related facilities experience lightning strikes and resulting fires when there were no instances of fires involving oil storage tanks due to lightning strikes?
